# 321 BROGDON ROAD

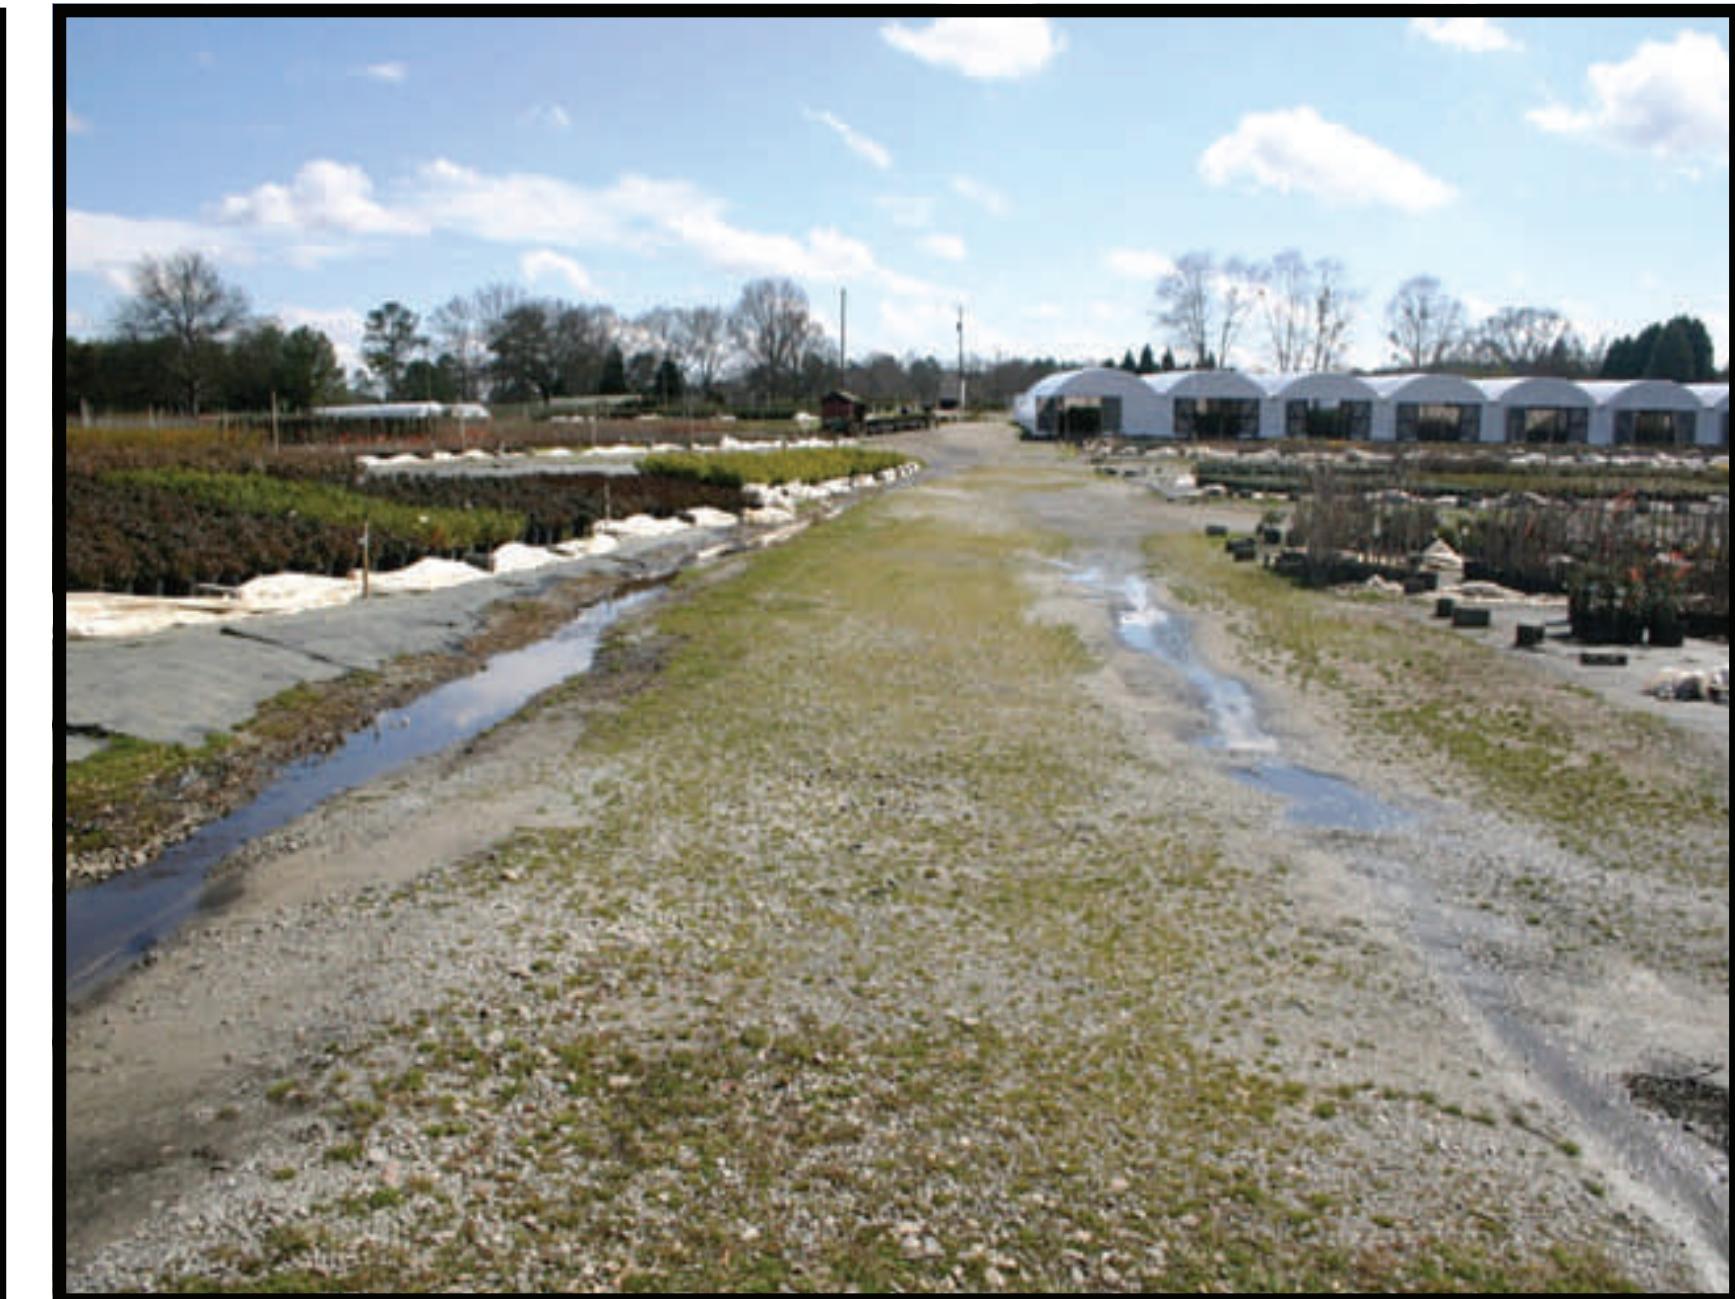
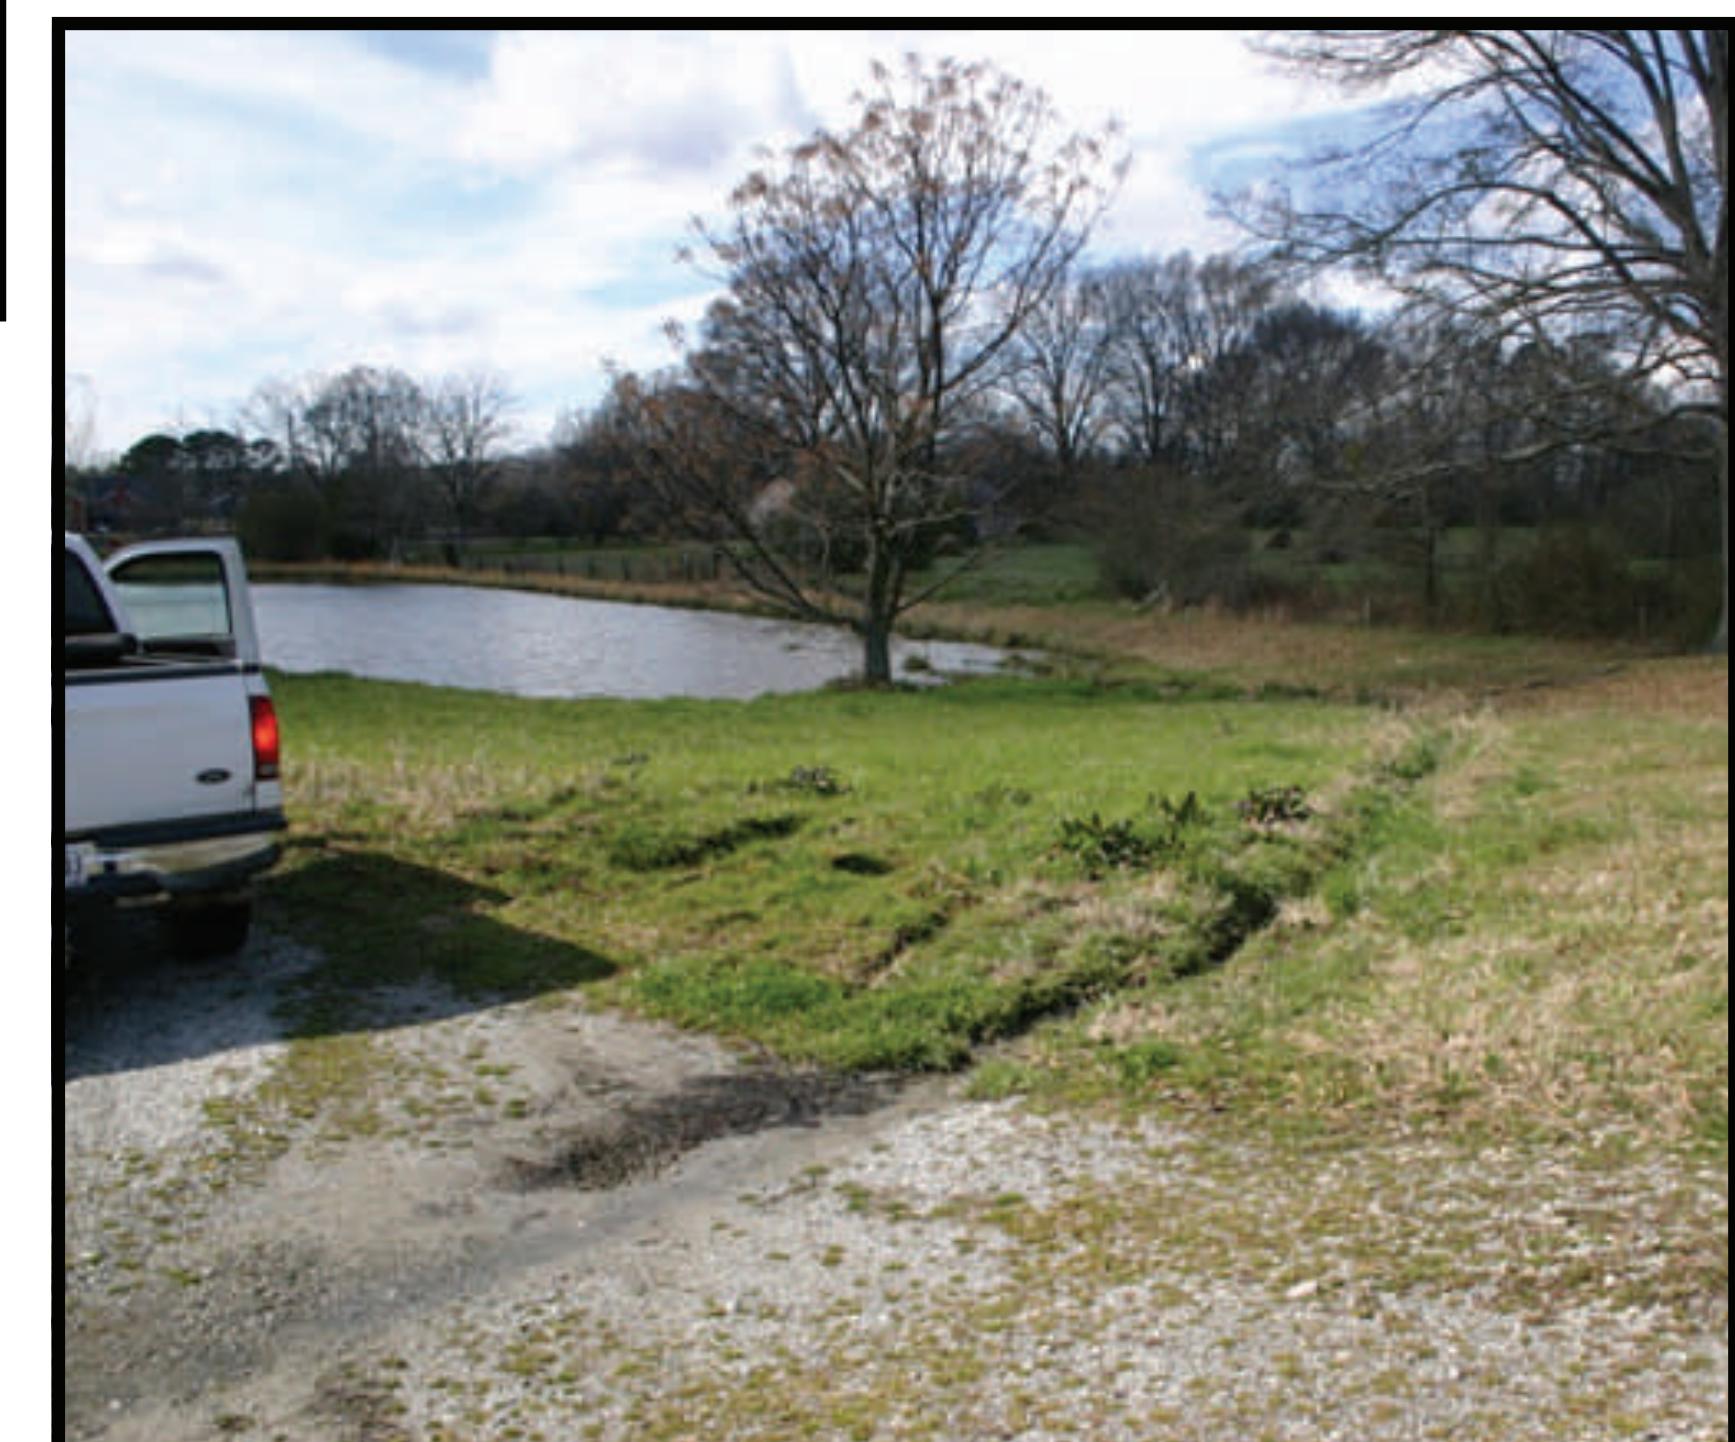
# 1692 S. Highway 92

•The white canopies are seasonal but were charged as impervious area.  
•Drainage ditches are throughout the property draining to ponds.  
•Pond is at capacity and will not detain stormwater during a major rain event.

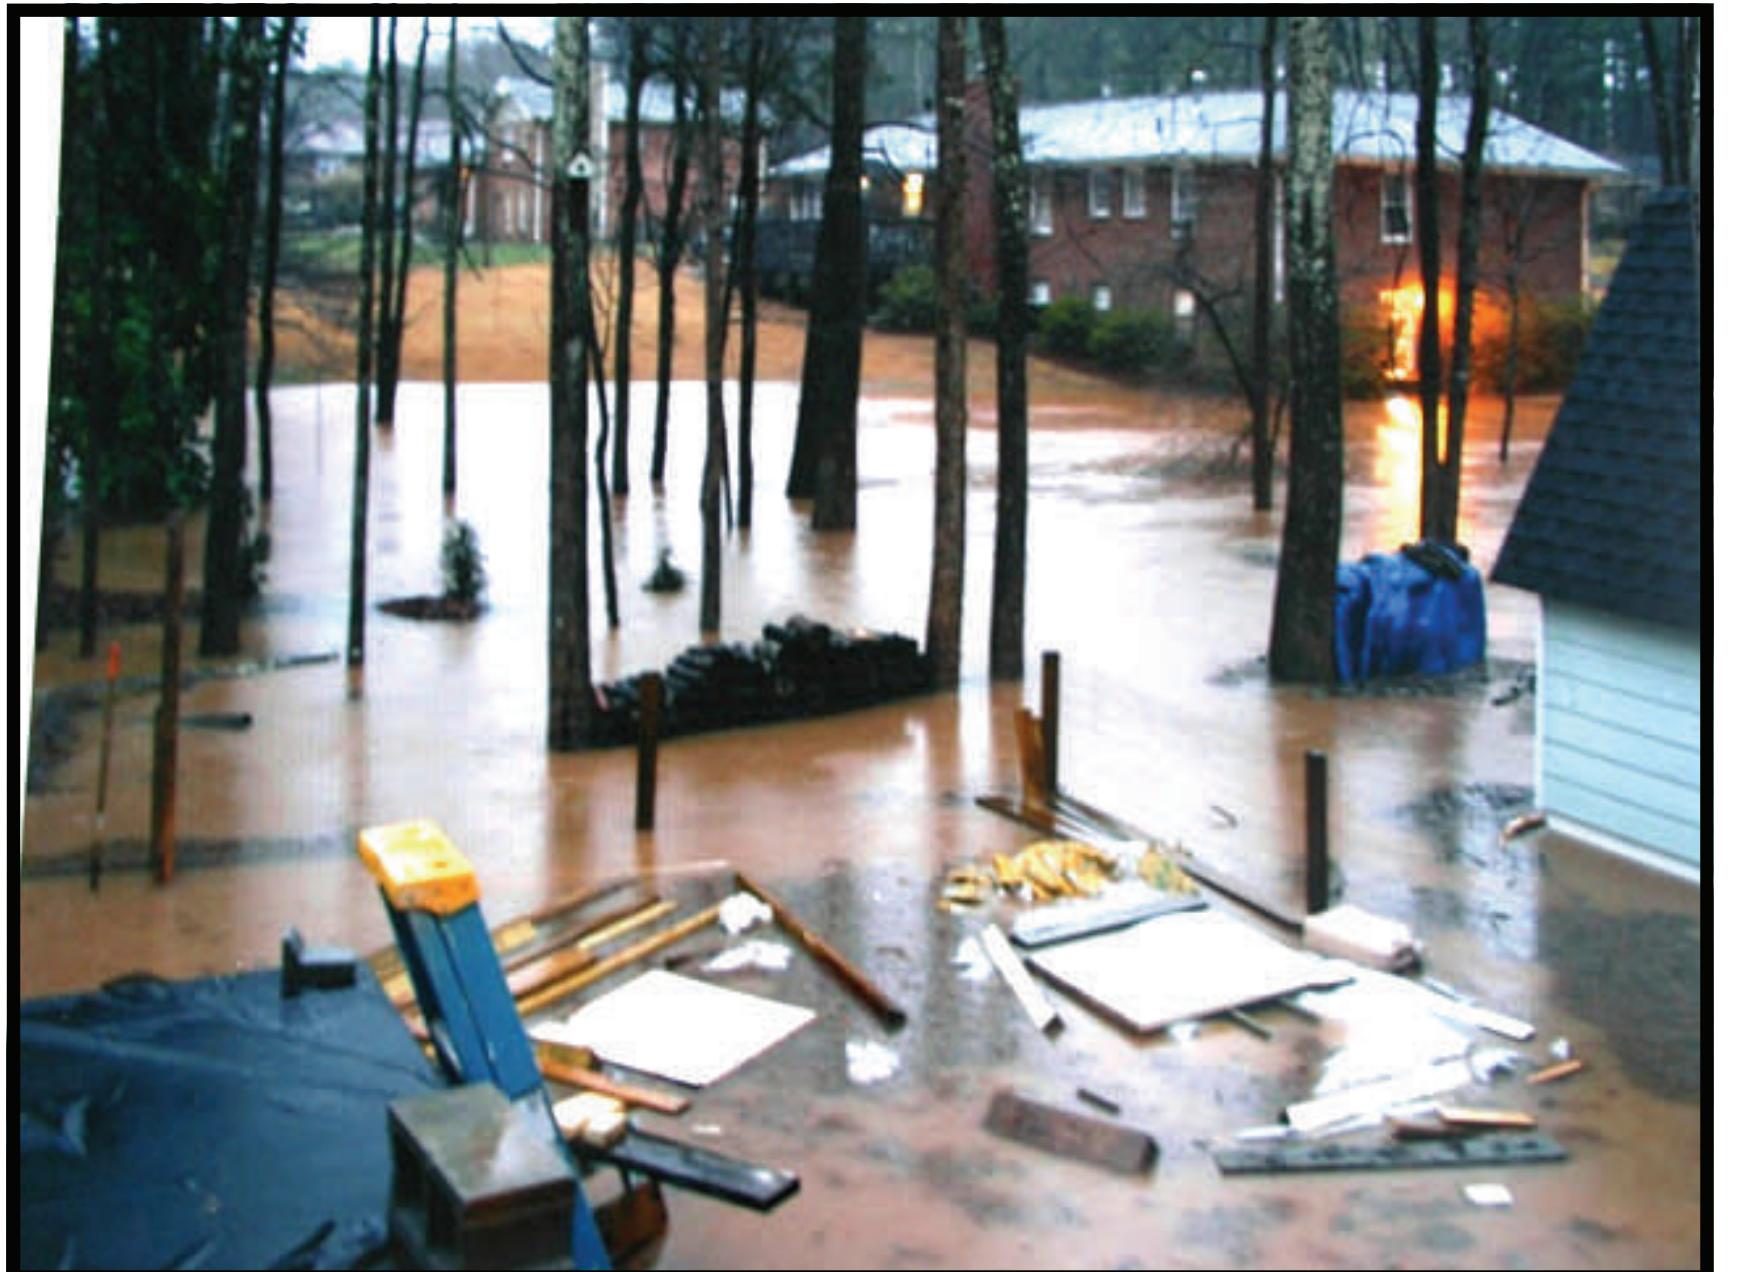
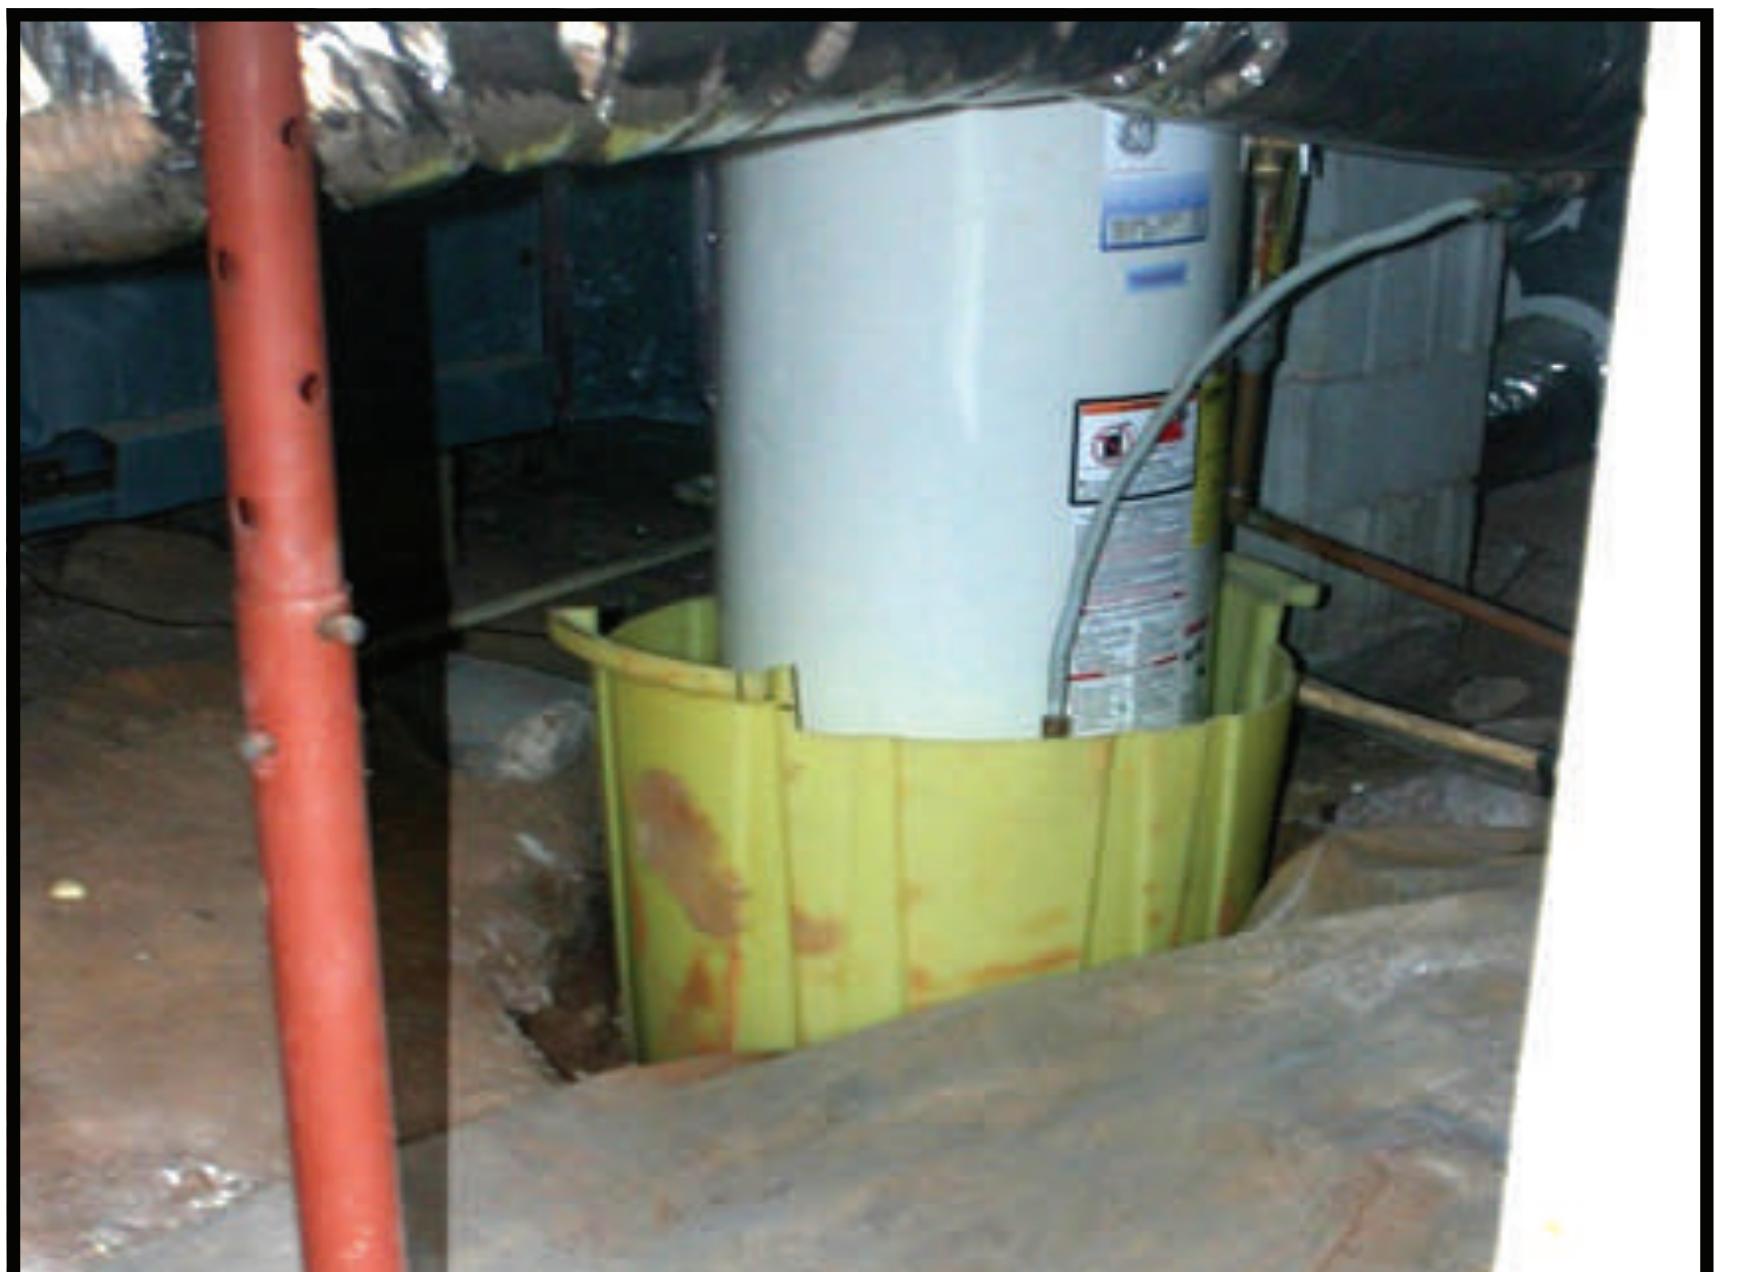
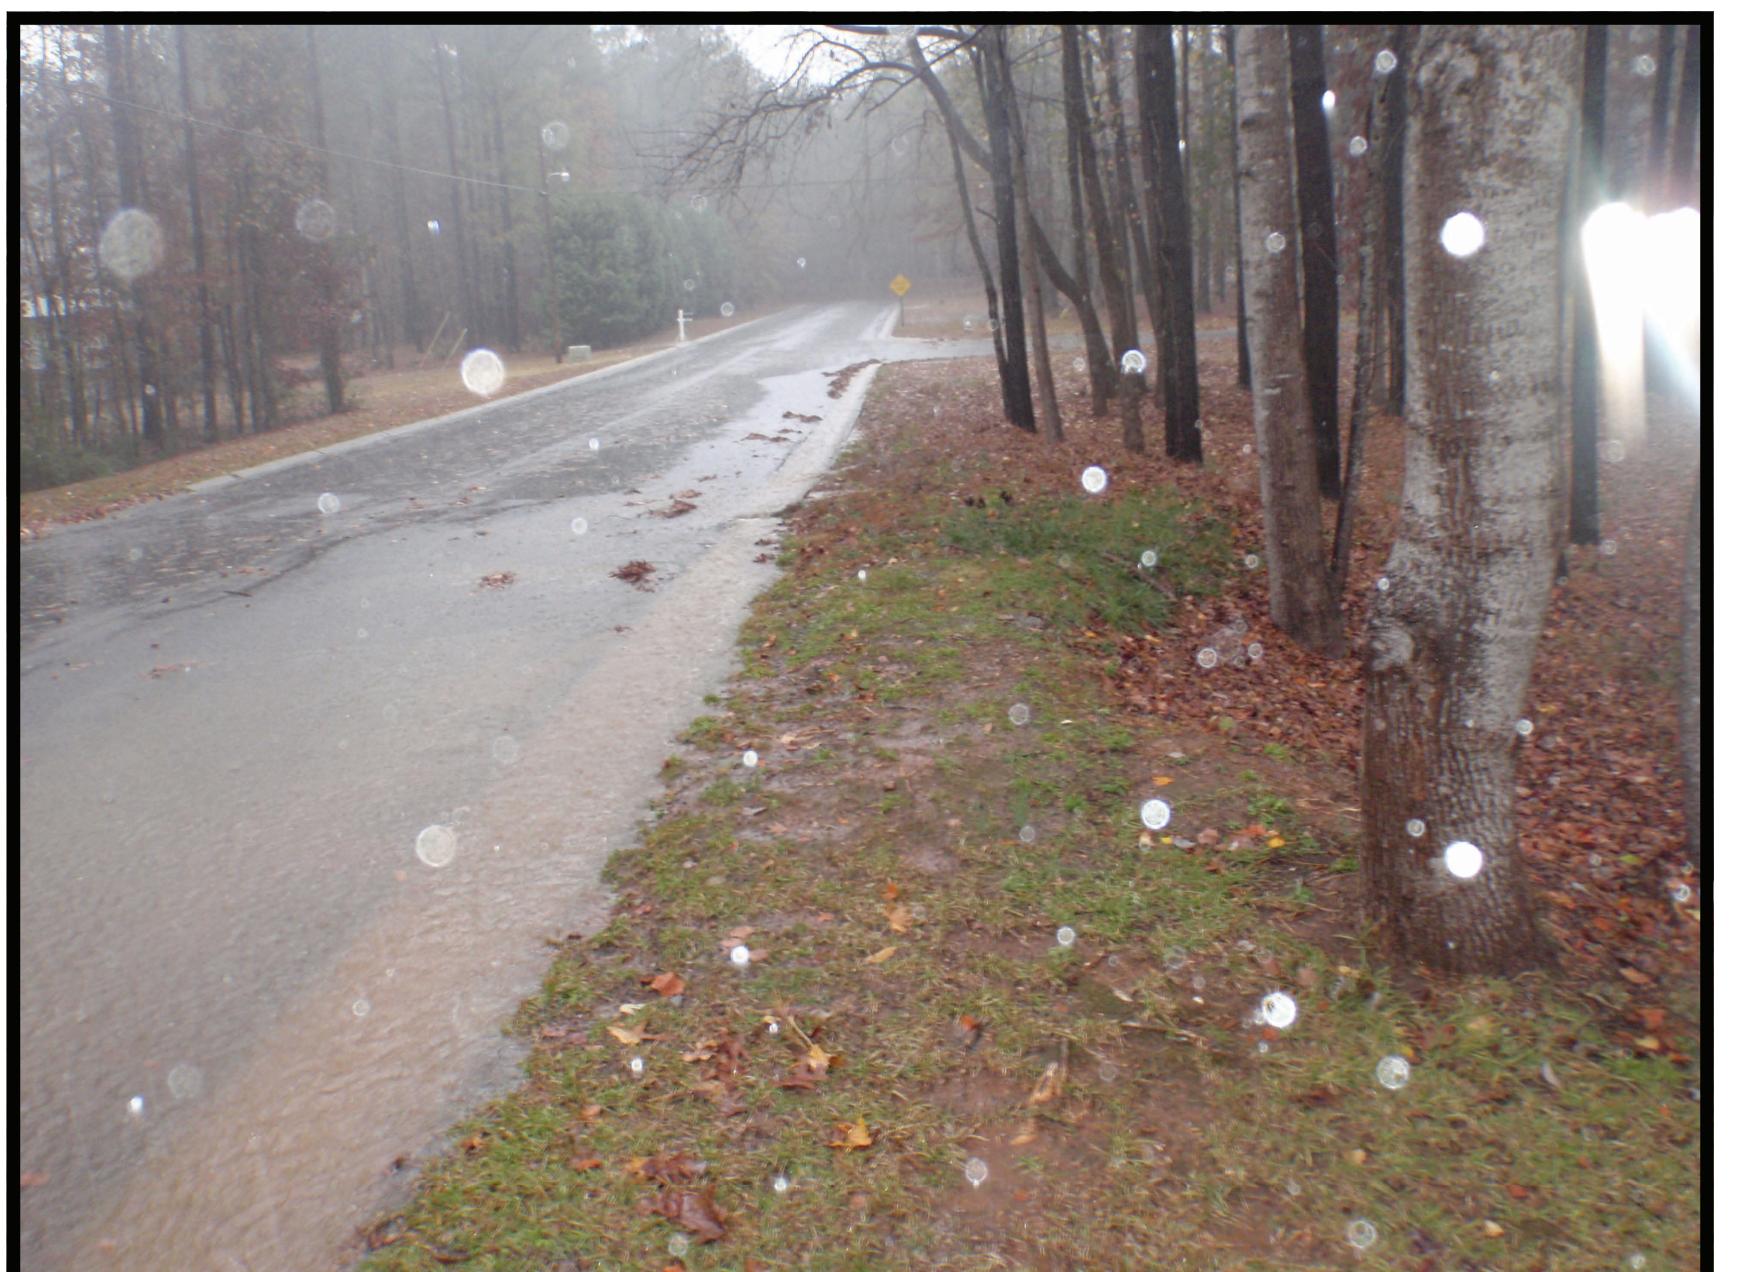
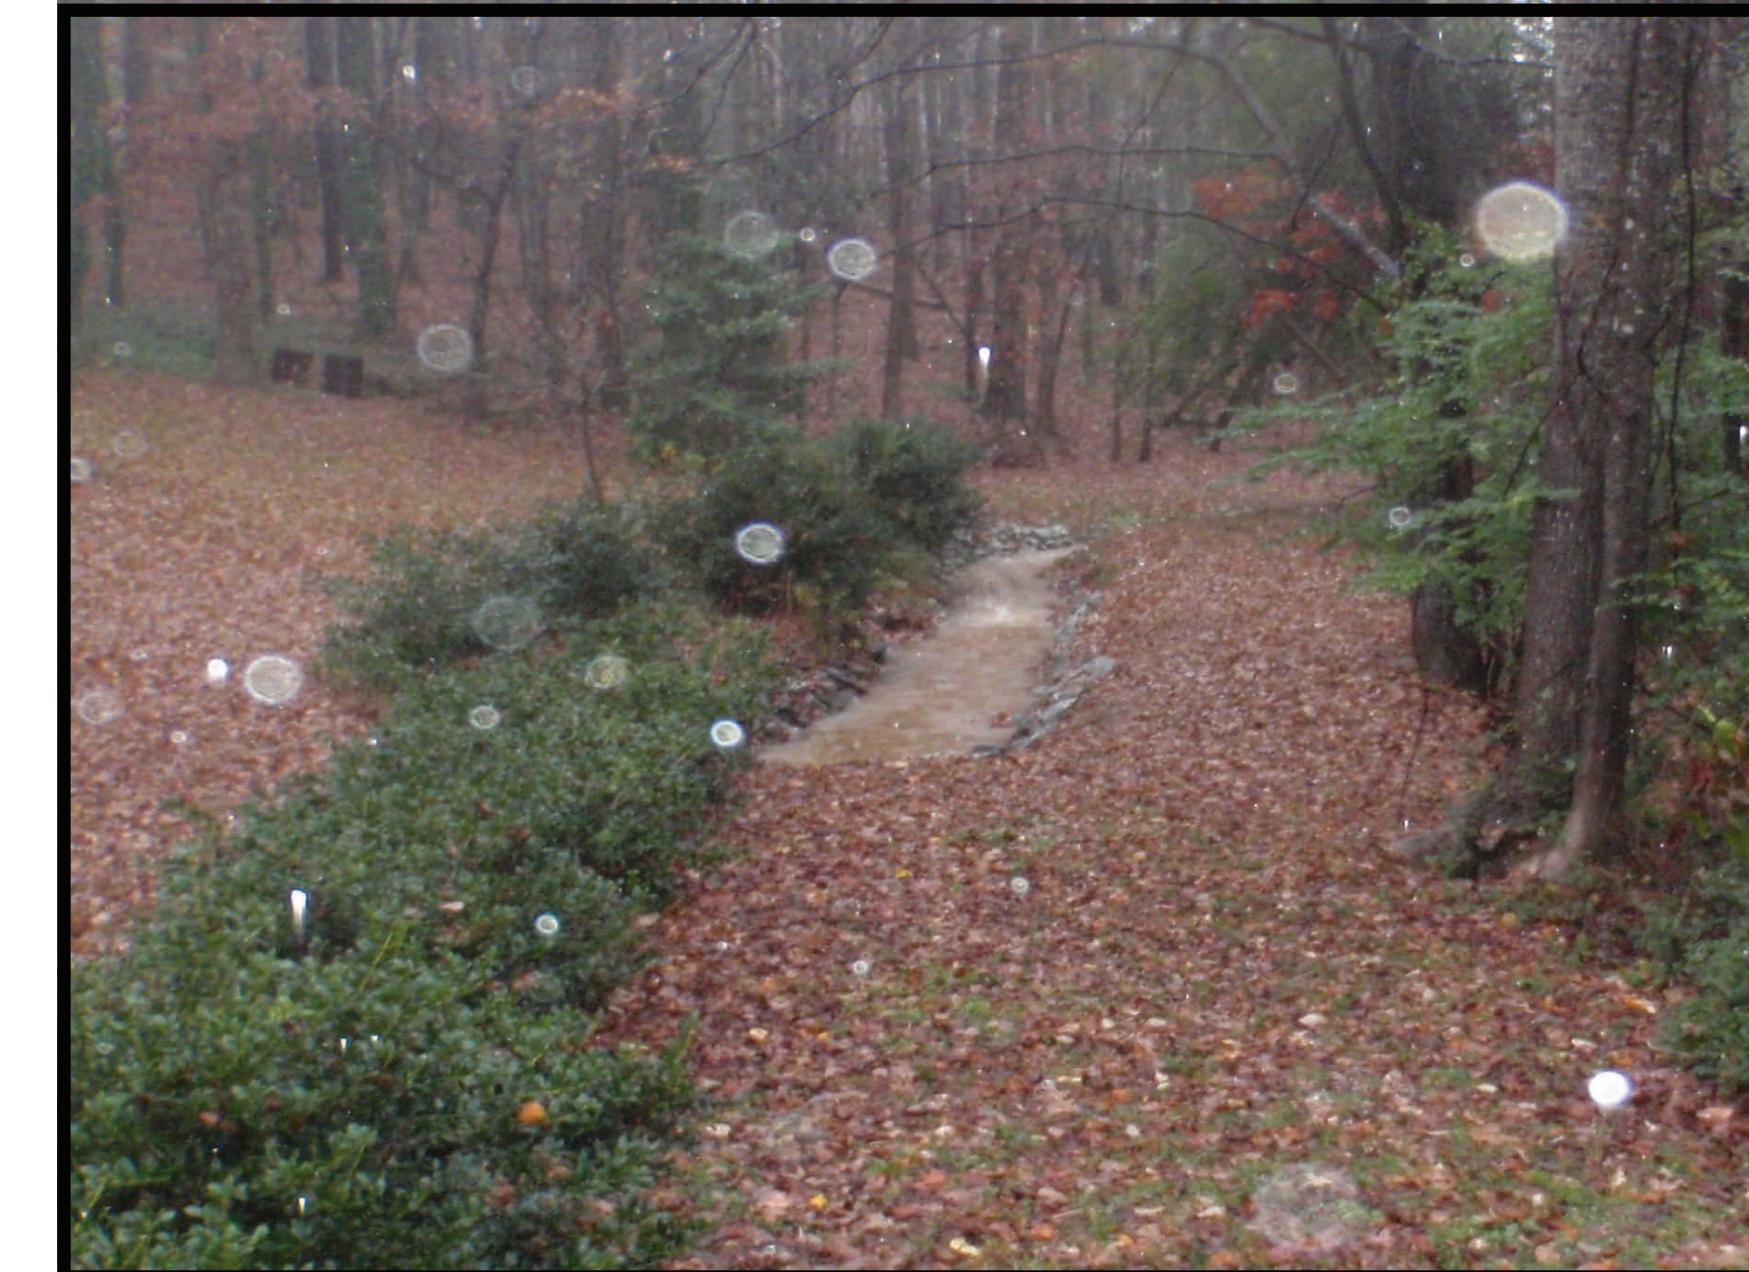
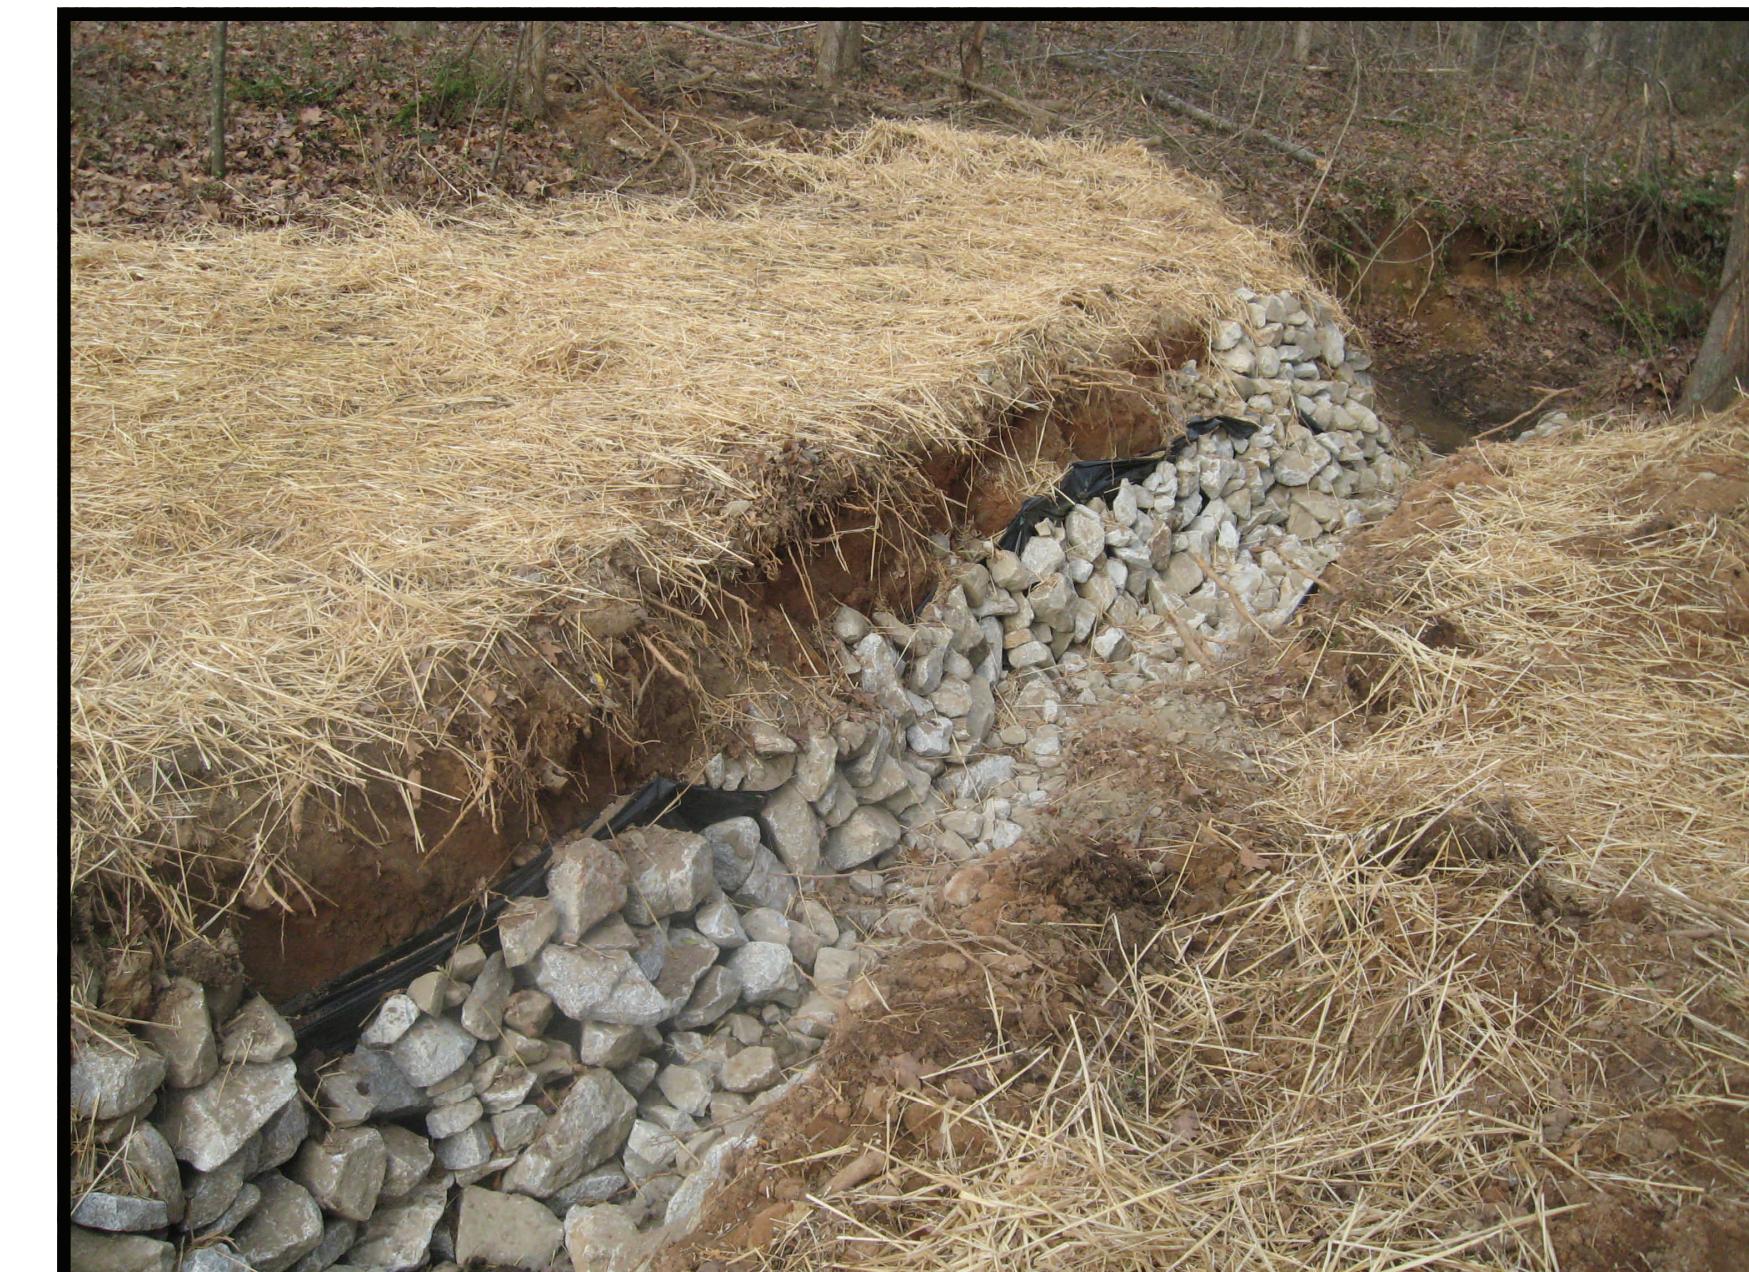
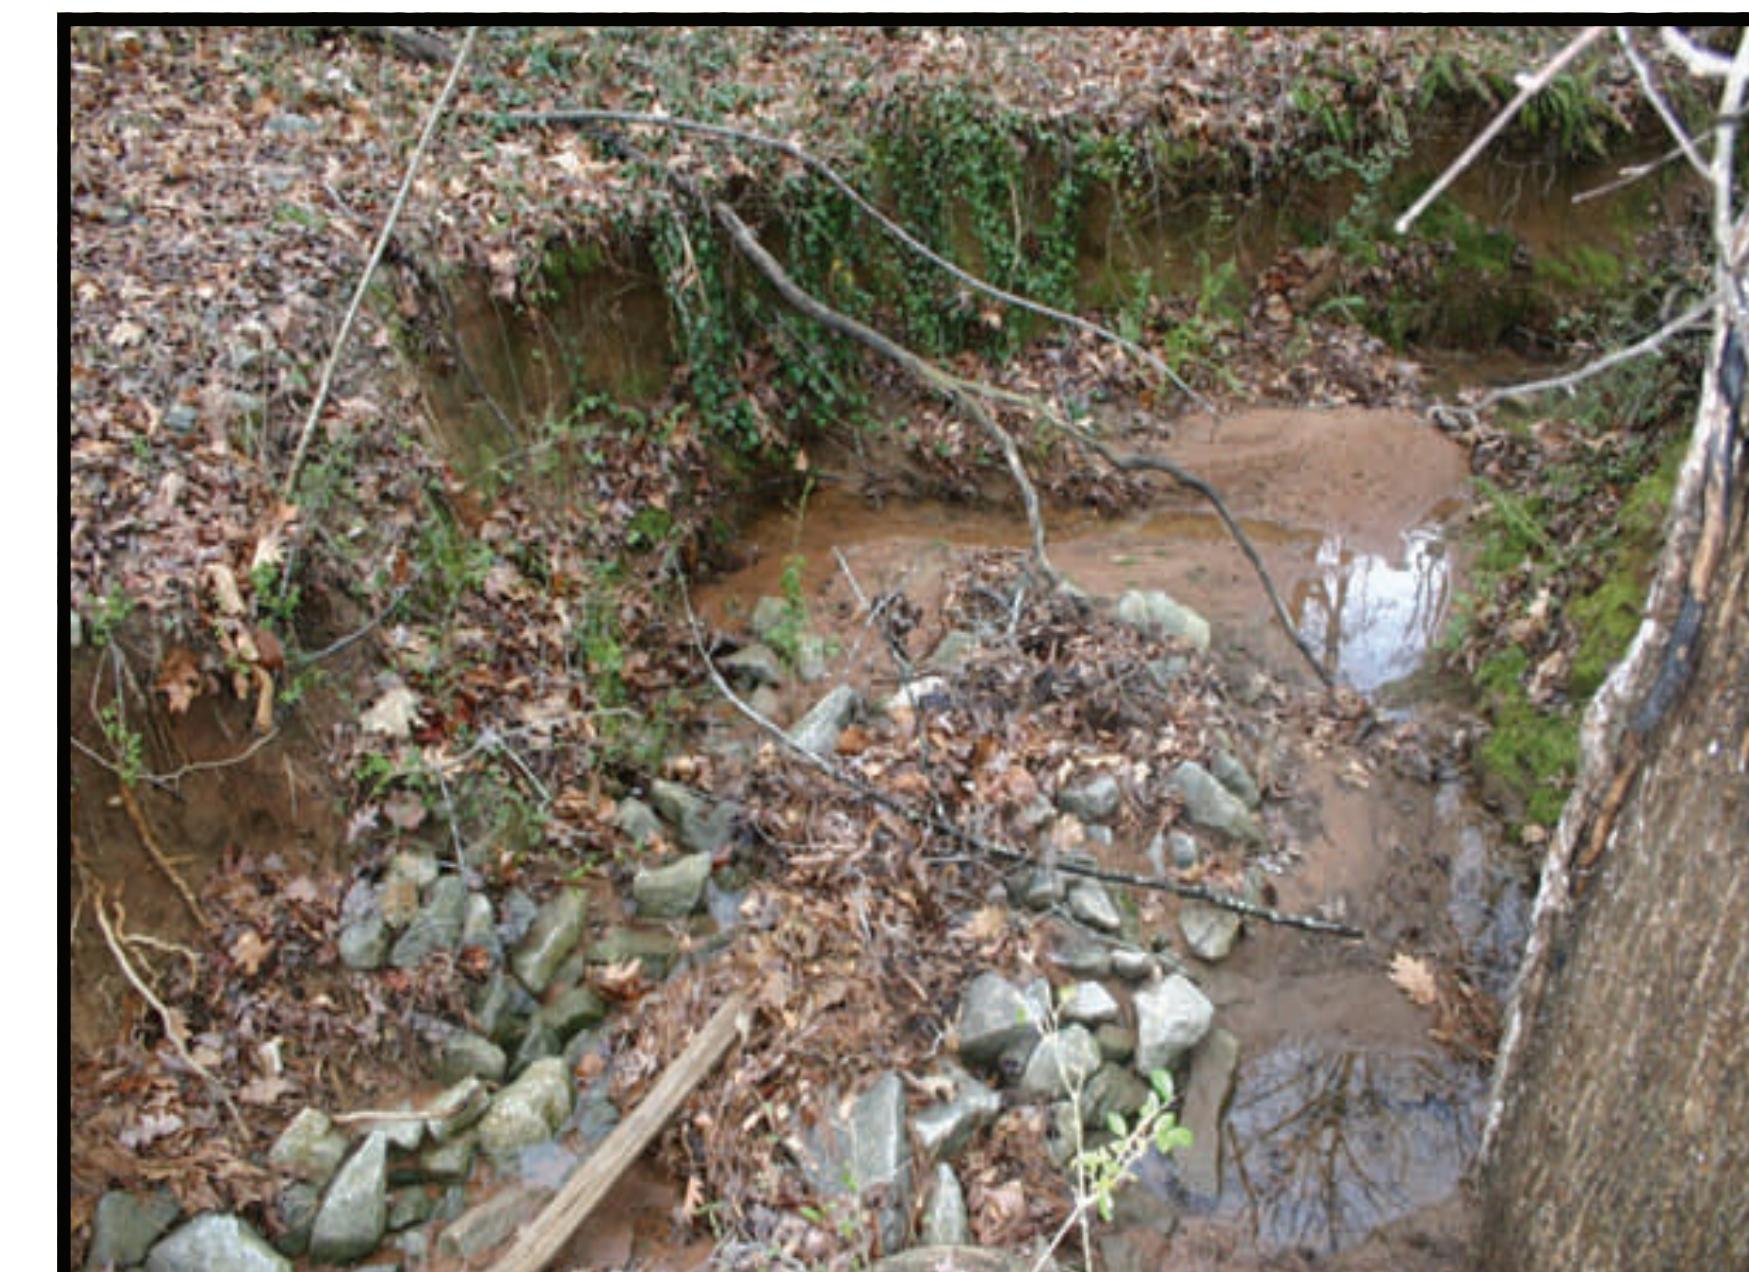
# AVALON DRIVE AND BRITTANY WAY, FAYETTE VILLA ESTATES

- Culvert is too small and rusting out causing flooding in basements and crawl spaces. Homeowner has complained since 2006.
- Rip-rap on the creek banks (other side of the culvert) has given way and erosion is evident.
- In 2011 County applied for a GEMA pre-disaster mitigation grant. Required only 25% match by county. Did not qualify because not enough damage incurred by homeowners.
- Failed attempt to correct the problem resulted concrete curb on both sides of the street never repaired.
